Inspection Report

Property Address:
33 Fairplay Road
Anywhere, NJ 07003

All In One Home Inspection LLC

| Date: 10/15/2007 | Time: 1:30 PM | Report ID: 2007_10_15 Smith |

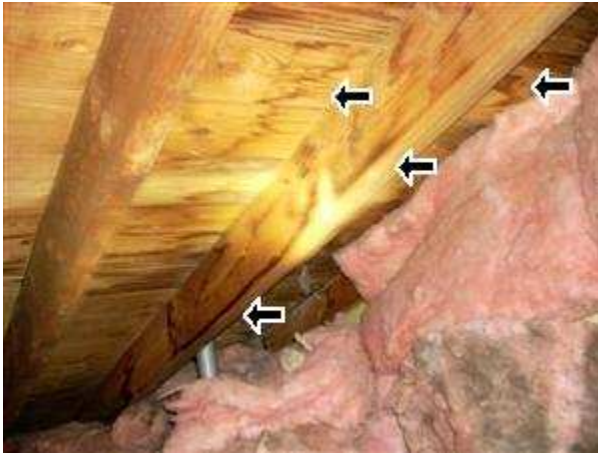
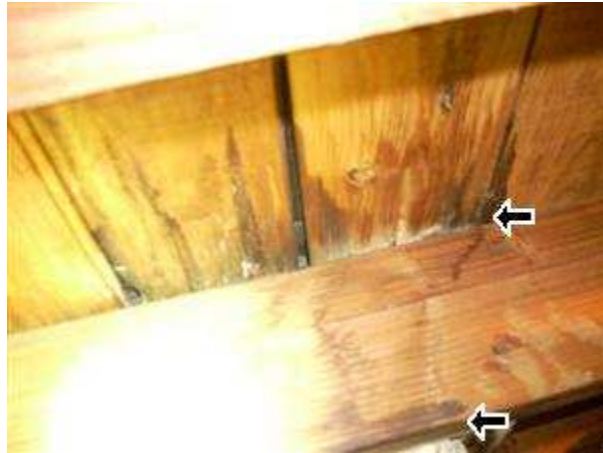
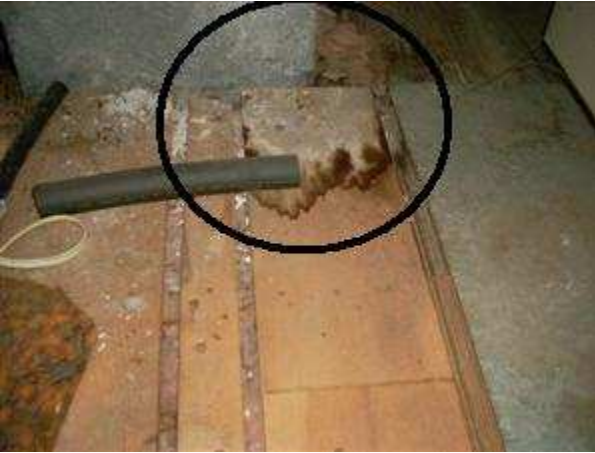
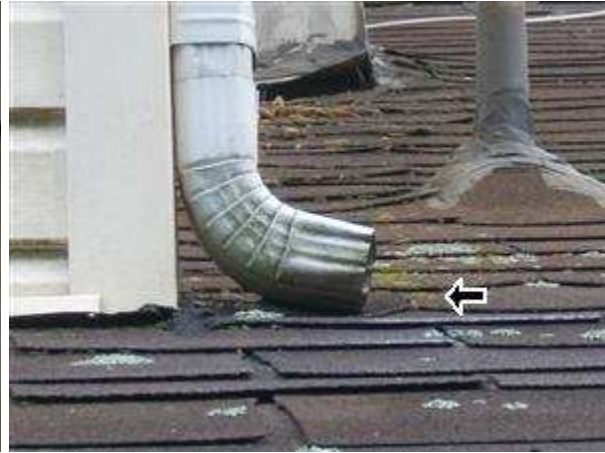
1.1 Picture 1

Leak stains present in attic behind ac/furnace by chimney. Does not appear to be ongoing and activity is not determined. Dry at time of inspection. This is in an area below additions' flashing and downspout. Monitor and have a qualified roofing contractor repair if necessary.

1.1 Picture 4 Note sag in sheathing

Leak stains present in attic behind ac/furnace by chimney. Does not appear to be ongoing and activity is not determined. Dry at time of inspection. This is in an area below additions' flashing and downspout. Monitor and have a qualified roofing contractor repair if necessary.

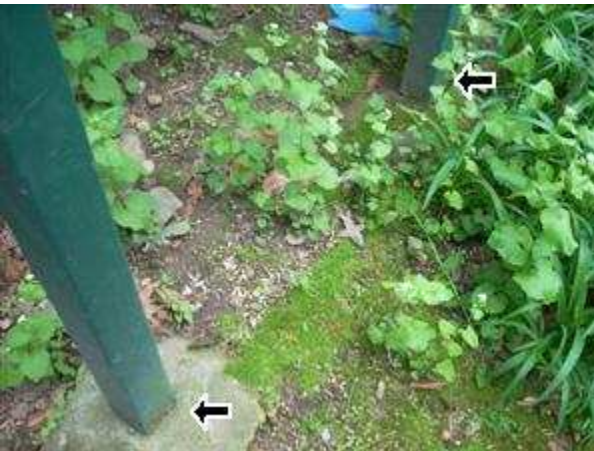
2.3 Picture 1

- 🏠 The deck railing at the rear of home is missing balusters. A fall or injury could occur if not corrected. Spacing more than 4 inches apart could allow an adult, child or pet to fall through. A qualified contractor should repair or replace as needed. Two wood posts below deck cantilever and stairs are "floating" or not supporting any weight. Recommend replacement and use of proper support "ties".

The deck railing at the rear of home is missing balusters. A fall or injury could occur if not corrected. Spacing more than 4 inches apart could allow an adult, child or pet to fall through. A qualified contractor should repair or replace as needed. Two wood posts below deck cantilever and stairs are "floating" or not supporting any weight. Recommend replacement and use of proper support "ties".

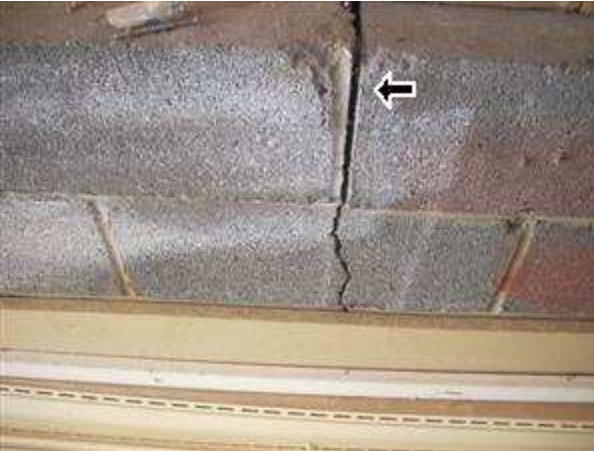
3.1 Picture 1

- 📍 South wall has heavy settlement crack. This does not appear to be active or detrimental. Recommend caulking to prevent insect ingress and monitoring for further movement.

South wall has heavy settlement crack. This does not appear to be active or detrimental. Recommend caulking to prevent insect ingress and monitoring for further movement.

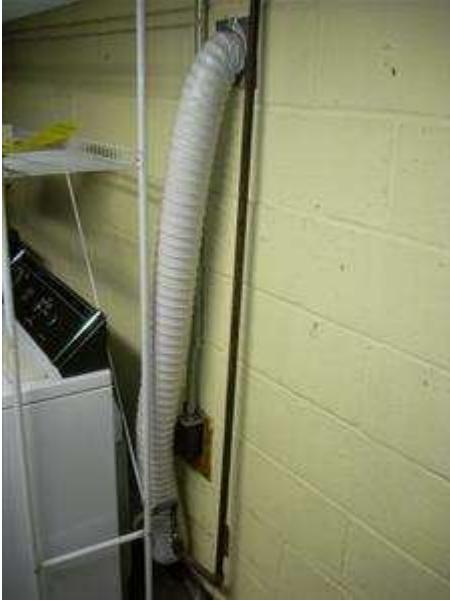
4.15 Picture 1

- 🏠 The dryer vent piping is plastic vinyl and is not recommended when dryer is powered by gas/propane. Some professionals consider plastic dryer vents as generally unsafe and recommend rigid or metal flexible pipe. I recommend repair as needed.

The dryer vent piping is plastic vinyl and is not recommended when dryer is powered by gas/propane. Some professionals consider plastic dryer vents as generally unsafe and recommend rigid or metal flexible pipe. I recommend repair as needed.

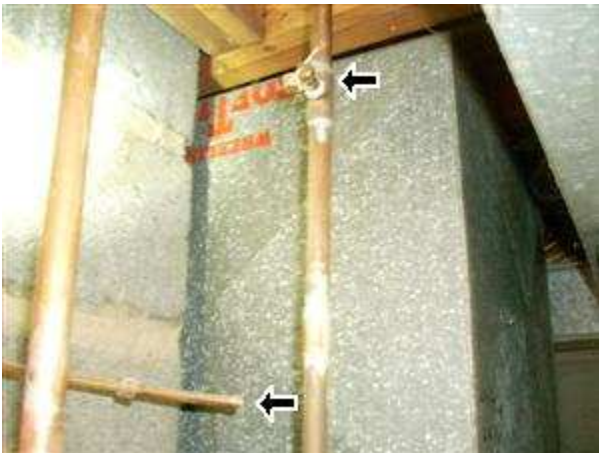
4.16 Picture 1

Water supply for refrigerator is not connected.

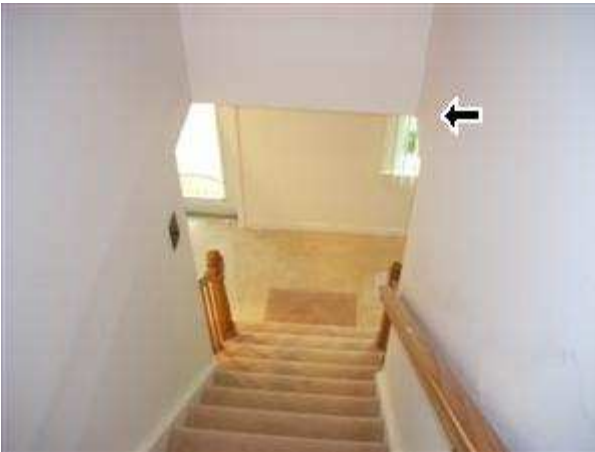
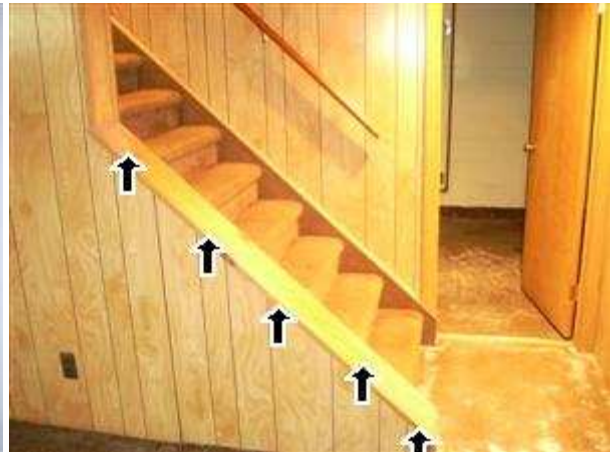
5.3.D Picture 1

Head height is below 6'8" on 2nd floor stairs. Basement stairs are missing balusters. This can be a safety hazard.

Head height is below 6'8" on 2nd floor stairs. Basement stairs are missing balusters. This can be a safety hazard.

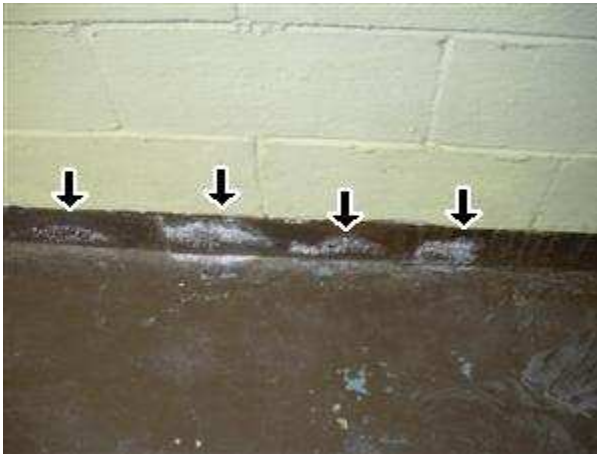
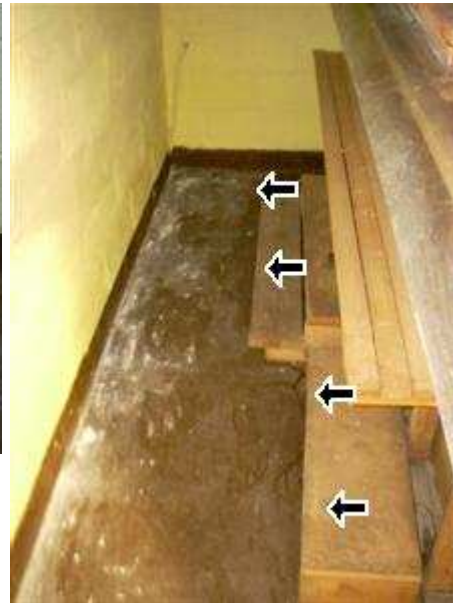
7.0 Picture 1

White efflorescence (powder substance) on block wall indicates moisture is in contact with the masonry. This does not necessarily indicate that intrusion will occur. I recommend checking the gutters and the downspout drain lines for proper operation. Also, a water proofing paint could be applied to the interior side of the block if necessary. Efflorescence is found on many homes without water intrusion occurring inside the home. But, it should alert you to the possibility that future steps may be needed.

7.0 Picture 2 Moisture trails from back corner

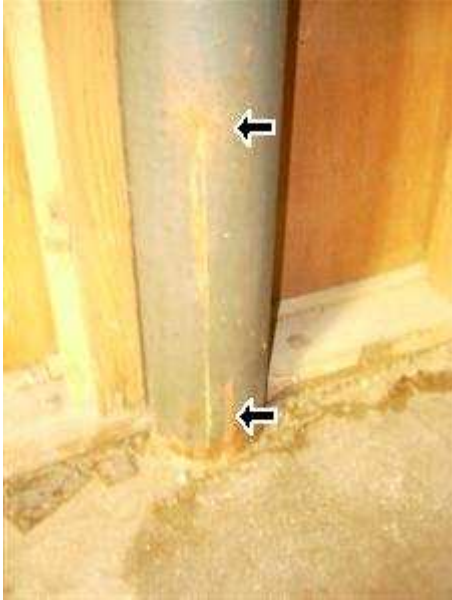
7.2 Picture 1

Rust blisters are present on steel lally columns in basement. Recommend cleaning and use of a rust

inhibiting paint. Eventual replacement may be necessary. Monitor and repair as necessary.

Rust blisters are present on steel lally columns in basement. Recommend cleaning and use of a rust inhibiting paint. Eventual replacement may be necessary. Monitor and repair as necessary.

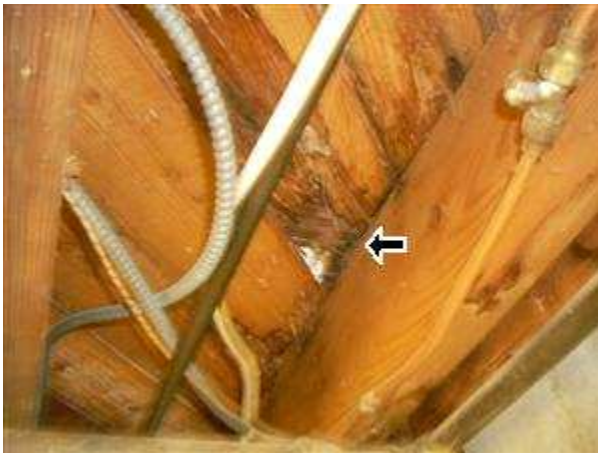
7.4 Picture 1

Several areas in basement ceiling of exposed framing have moisture stains. Noticeably the north wall and area under refrigerator. This does not appear to be ongoing. Most of the walls and ceilings in the finished basement are covered and structural members are not visible. No obvious problems discovered. I could not see behind these coverings.

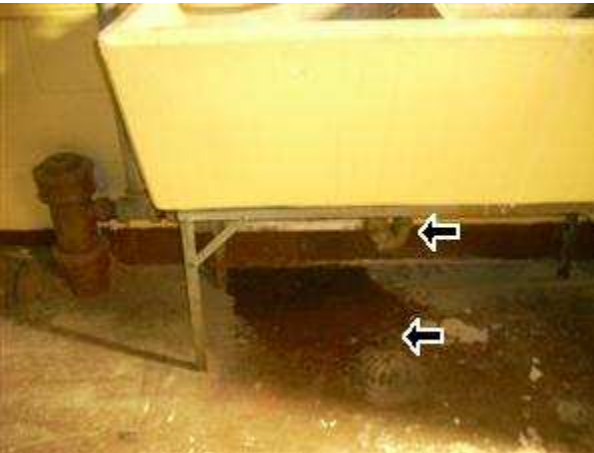
8.1 Picture 1

Basement sink is actively leaking. Tub is cracked.

Basement sink is actively leaking. Tub is cracked.

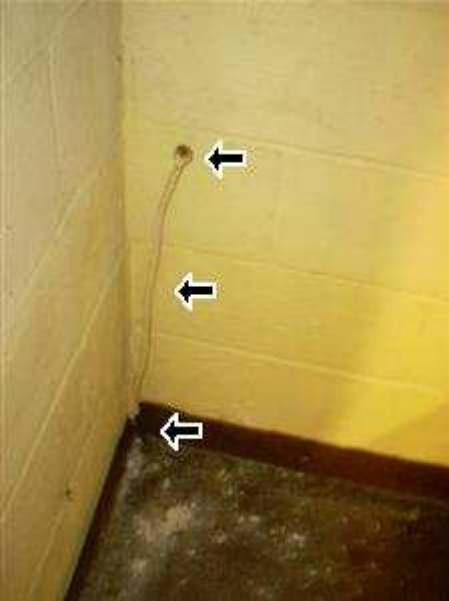
8.4 Picture 1

Abandoned oil line present in NE corner of basement. Patched holes in basement wall indicate oil tank may have been in basement before removal. Consult a tank search contractor for confirmation.

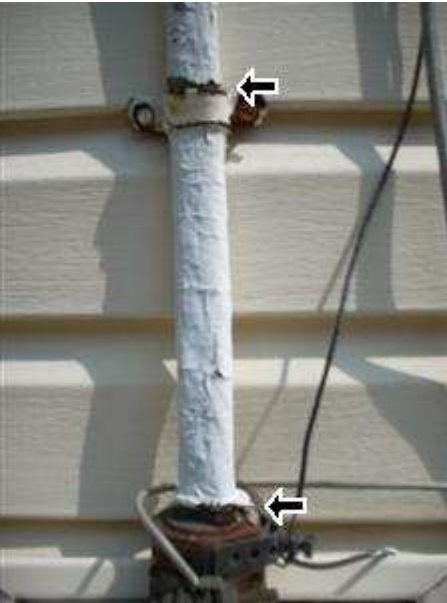
9.0 Picture 1

- The problem(s) discovered with Service Entrance Conductors such as weather seal is deteriorated, conduit frayed, and any other problems that an electrician may discover while performing repairs need correcting. I recommend a licensed electrician inspect further and correct as needed.

The problem(s) discovered with Service Entrance Conductors such as weather seal is deteriorated, conduit frayed, and any other problems that an electrician may discover while performing repairs need correcting. I recommend a licensed electrician inspect further and correct as needed.

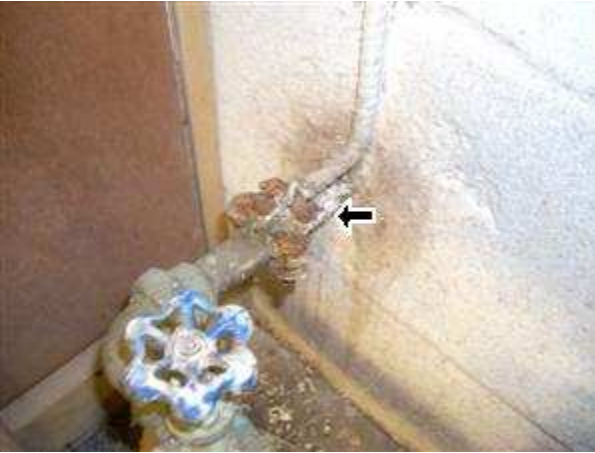
9.1 Picture 1

- Some labels are present, but are illegible or confusing. I recommend correcting for safety reasons. The ground wire clamp at plumbing entrance is heavily corroded. Ground contact suspect. Recommend replacement.

Some labels are present, but are illegible or confusing. I recommend correcting for safety reasons. The ground wire clamp at plumbing entrance is heavily corroded. Ground contact suspect. Recommend replacement.

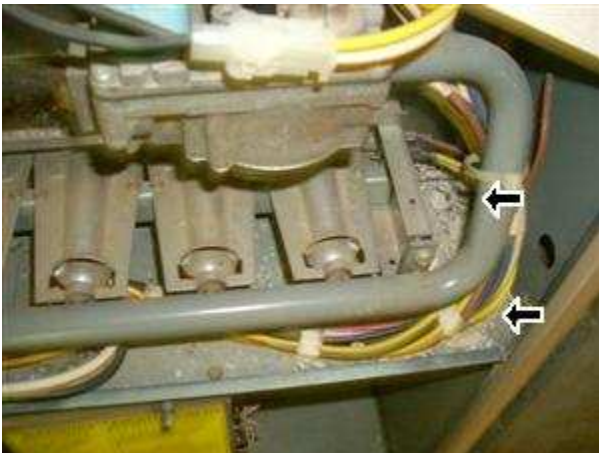
10.0 Picture 1

Debris in furnace burner area needs cleaning and reinspection.

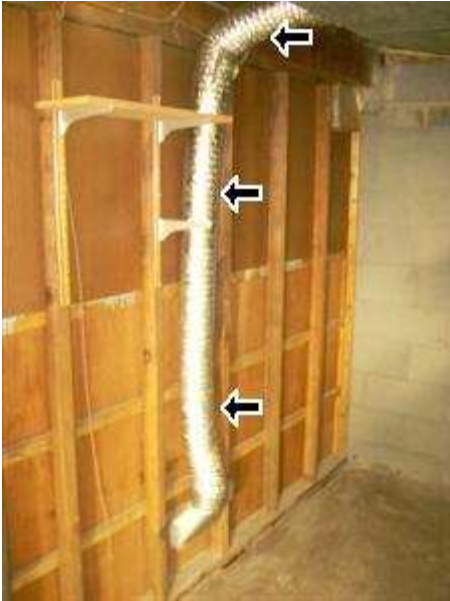
10.3 Picture 1

Un insulated dryer vent used for ac/heat duct in basement. Condensation formed quickly. Recommend replacing with insulated duct.

Un insulated dryer vent used for ac/heat duct in basement. Condensation formed quickly. Recommend replacing with insulated duct.

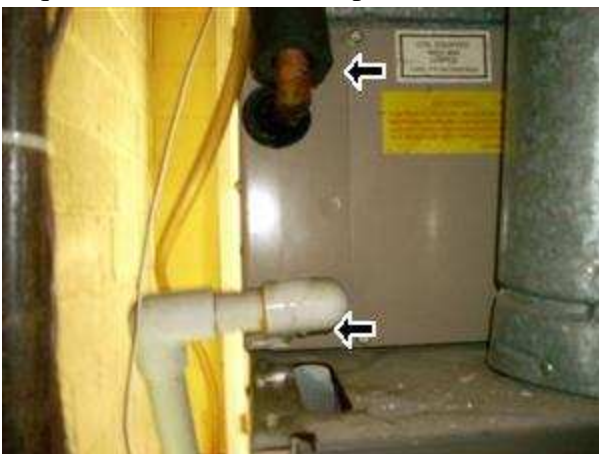
- 🏠 Condensation is dripping from elbow missing insulation down through exchanger cabinet. Have an qualified HVAC tech inspect further and correct.

10.8 Picture 1 Condensation drip

Condensation is dripping from elbow missing insulation down through exchanger cabinet. Have an qualified HVAC tech inspect further and correct.

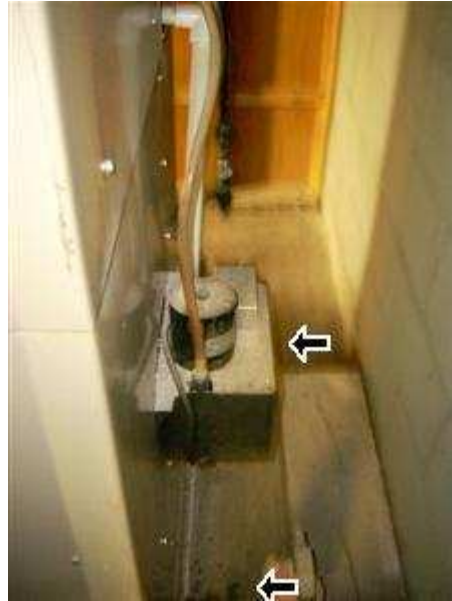
10.8 Picture 2 Leak at condensate pump

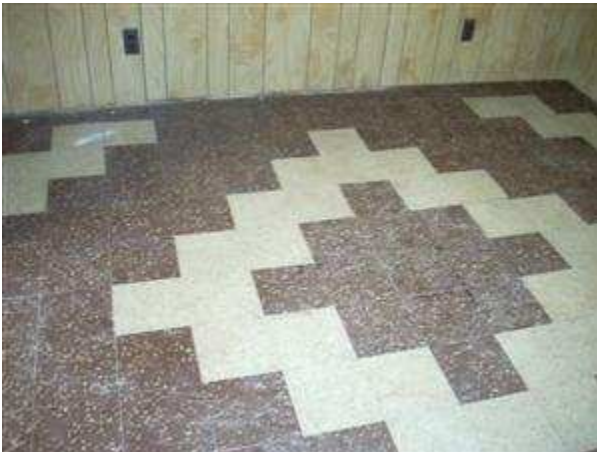
10.11 Picture 1

Old tiles present in basement may possibly contain asbestos. Lab tests are necessary to determine. Not currently "Friable".
